**Flood Control Project Maintenance
Levee Inspections**

Spring 2012 Levee Inspection Results

Reclamation District No. 2031 Elliot

Waterway			Bank	Unit Miles
Unit No. 01 Stanislaus River			Left	7.15
	Spring (March - May)	Summer (June - August)	(September - November) Fall	Winter (December - February)
Unit Maintenance Rating (Fall Only)				
Date of Inspection	5/15/2012 - 5/15/2012			
DWR Inspector	Max Khashchuk			
Accompanied By	Bob Buckmaster

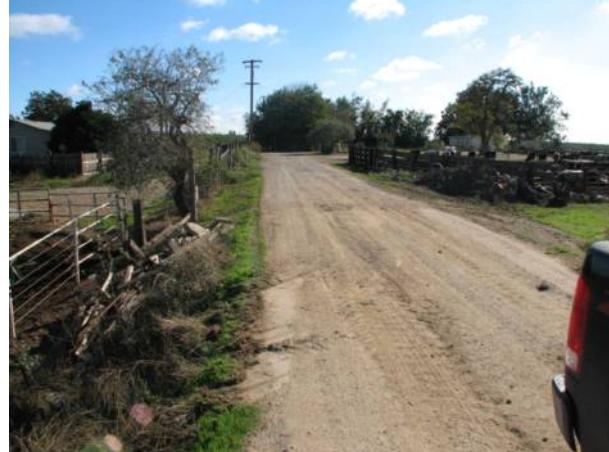
Levee Mile Report Line	4
Start Levee Mile	0.00
End Levee Mile	0.07
Location	Water Side
Category	Earthen Levee
Item	Encroachments
Fall 2009 photo looking upstream at beginning of unit 1. Water side to the left.	
mkhashch_s_20120501_039.jpg

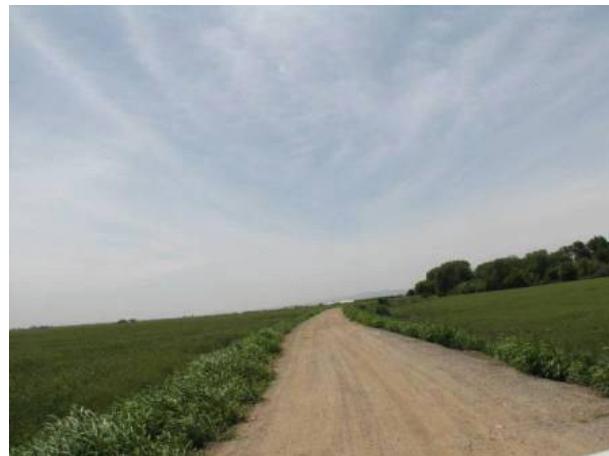
Levee Mile Report Line	5
Start Levee Mile	0.06
End Levee Mile	0.06
Location	Water Side
Category	Earthen Levee
Item	Vegetation
View of tall grass blocking visibility on both slopes of levee, facing downstream. 05/02/2012	
mkhashch_s_20120510_075.jpg

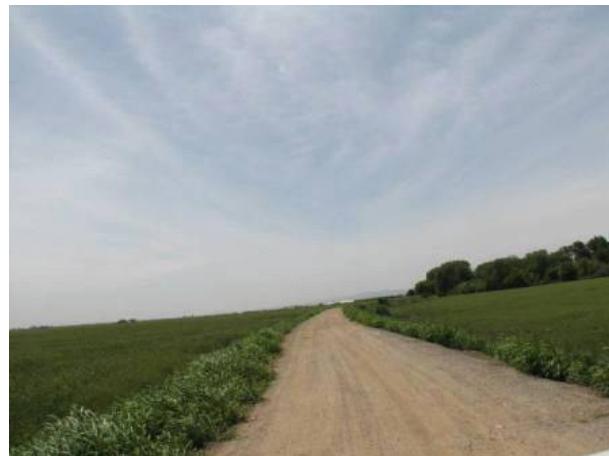
Levee Mile Report Line	6
Start Levee Mile	0.08
End Levee Mile	0.08
Location	Land Side
Category	Earthen Levee
Item	Vegetation
View of tall grass blocking visibility on both slopes of levee, facing downstream. 05/02/2012	
mkhashch_s_20120510_074.jpg

Ma						-121.156647 ° -121.156647 ° Y	
											DWR ID: DWR_RD2031_01_s_2012_22
6	0.08 0.08	Earthen Levee	Vegetation	LS M	V1 : Control annual grass and weeds on the levee slopes and easements.					37.709895 ° 37.709895 ° 14	
				Ma						-121.156687 ° -121.156687 ° Y	
											DWR ID: DWR_RD2031_01_s_2012_14
7	0.15 0.15	Earthen Levee	Encroachments	LS A/W	PI : Pipe					37.708780 ° 37.708780 ° 30	
				En						-121.156830 ° -121.156830 ° Y	
											DWR ID: DWR_RD2031_01_s_2012_30
8	0.34 0.52	Earthen Levee	Encroachments	LS M	FE : Fences					37.706148 ° 37.704030 ° 7	
				En						-121.157975 ° -121.159653 ° Y	
											DWR ID:
9	0.46 0.46	Interior Drainage & Piping Systems	Flap Gates	WS U	Inspector Comments: Canal outlet has no flap gate on waterward side.					37.704772 ° 37.704772 ° 32	
				Ma						-121.158990 ° -121.158990 ° Y	
											DWR ID: DWR_RD2031_01_s_2012_32

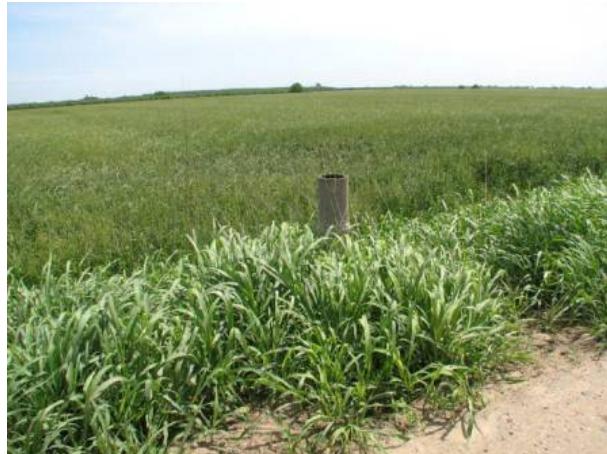
Levee Mile Report Line	7
Start Levee Mile	0.15
End Levee Mile	0.15
Location	Land Side
Category	Earthen Levee
Item	Encroachments
View of pipe in landward slope of levee, facing downstream. 05/02/2012	mkhashch_s_20120510_076.jpg

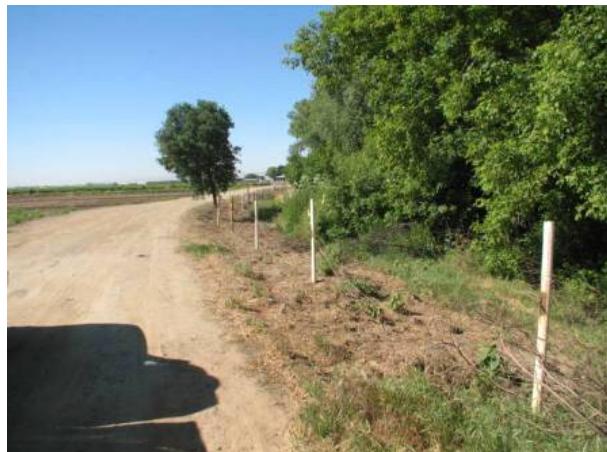
Levee Mile Report Line	8
Start Levee Mile	0.34
End Levee Mile	0.52
Location	Land Side
Category	Earthen Levee
Item	Encroachments
05/10/2011 Fence on waterside prevents access to waterside slope.	mkhashch_s_20120501_031.jpg

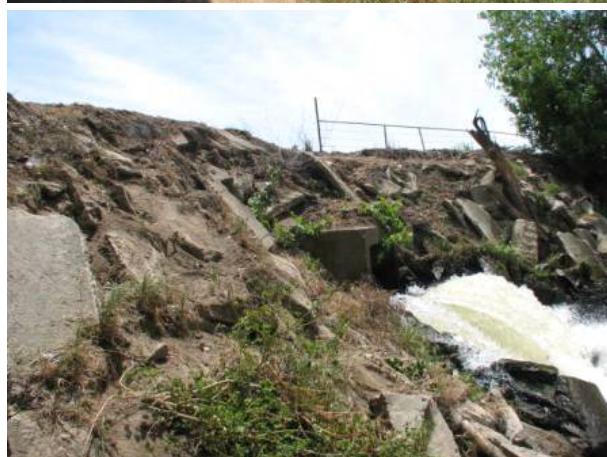
Levee Mile Report Line	9
Start Levee Mile	0.46
End Levee Mile	0.46
Location	Water Side
Category	Interior Drainage & Piping Systems
Item	Flap Gates
View of canal outlet on waterward slope facing downstream. 05/02/2012	mkhashch_s_20120510_077.jpg

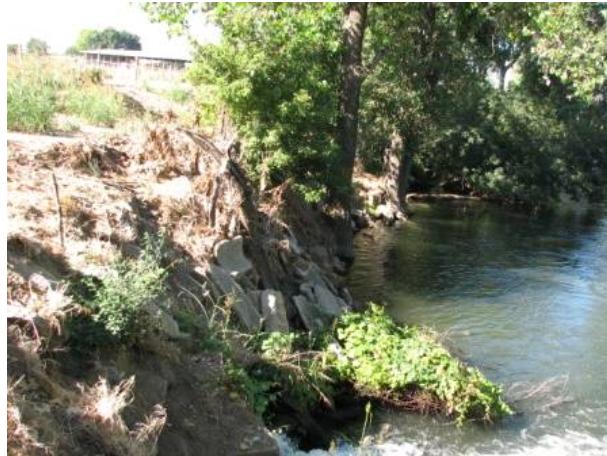
Levee Mile Report Line	10
Start Levee Mile	0.47
End Levee Mile	0.50
Location	Water Side
Category	Supplemental
Item	DWR Erosion Survey
Looking downstream of the site.	
mkhashch_s_20120501_025.jpg

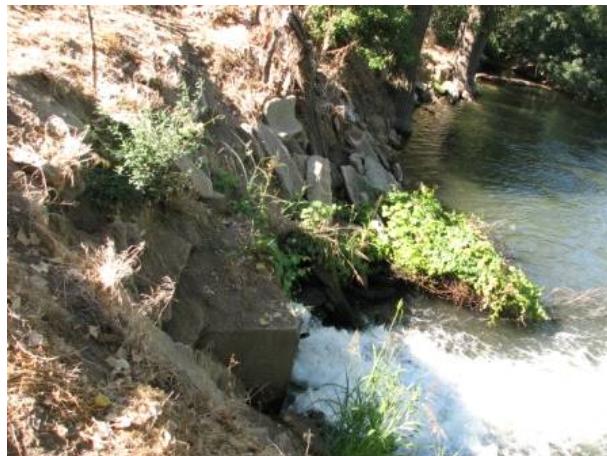
Levee Mile Report Line	10
Start Levee Mile	0.47
End Levee Mile	0.50
Location	Water Side
Category	Supplemental
Item	DWR Erosion Survey
Looking downstream of the site. The irrigation outlet operating. Debris at the outlet visible	
mkhashch_s_20120501_026.jpg

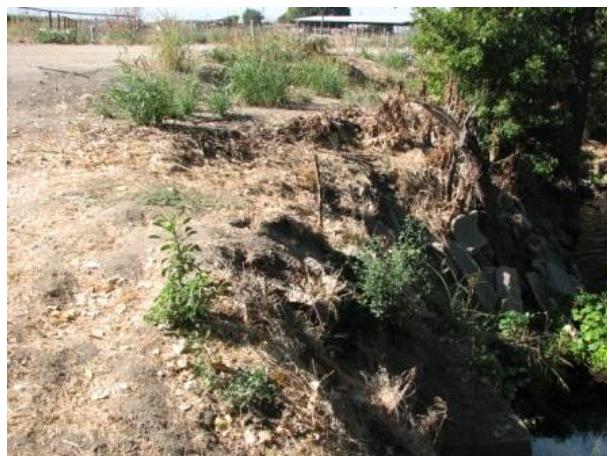
Levee Mile Report Line	10
Start Levee Mile	0.47
End Levee Mile	0.50
Location	Water Side
Category	Supplemental
Item	DWR Erosion Survey
View of the current condition of the levee slope just above the irrigation outlet.	
mkhashch_s_20120501_027.jpg

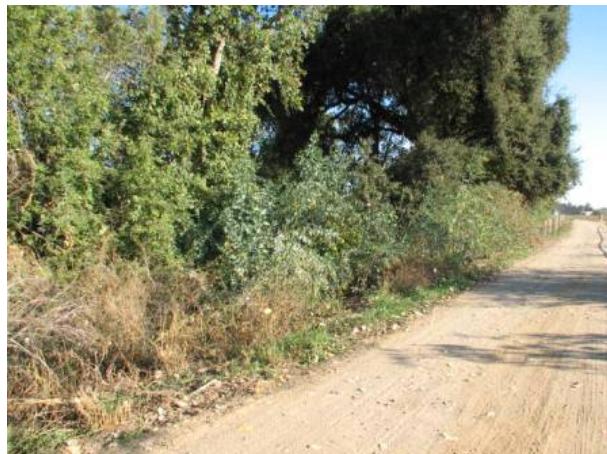
Levee Mile Report Line	11
Start Levee Mile	0.52
End Levee Mile	0.52
Location	Water Side
Category	Earthen Levee
Item	Vegetation

10/26/2011 Updated photo of waterside vegetation.

11	0.52	0.52	Earthen Levee	Vegetation	WS	M Ma	V2 : Remove the wild growth other than native grasses from the levee slopes.	37.704050 ° -121.159578 °	37.704050 ° -121.159578 °	2 Y
										DWR ID: DWR_RD2031_01_s_2012_2
12	0.55	0.65	Earthen Levee	Encroachments	LS	U En	BU : Buildings Inspector Comments: Corrals and house on levee slope and crown.	37.703626 ° -121.159714 °	37.702648 ° -121.160700 °	969 Y
										DWR ID: DWR_RD2031_01_s_2012_969
13	0.63	0.63	Earthen Levee	Encroachments	CR	M En	EQ : Equipment Inspector Comments: Vehicles parked on crown of levee.	37.703005 ° -121.160567 °	37.703005 ° -121.160567 °	33 Y
										DWR ID: DWR_RD2031_01_s_2012_33
14	0.64	0.71	Earthen Levee	Encroachments	LS	M En	FE : Fences	37.702814 ° -121.160562 °	37.701875 ° -121.161670 °	4 Y
										DWR ID: DWR_RD2031_01_s_2012_4
15	0.64	0.64	Earthen Levee	Crown Surface / Depressions / Rutting	CR	M Ma	C2 : Regrade the crown roadway for proper drainage.	37.702766 ° -121.160598 °	37.702766 ° -121.160598 °	970 Y

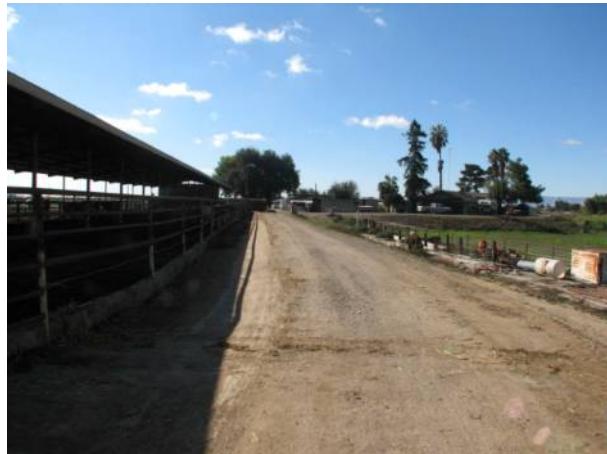
Levee Mile Report Line	12
Start Levee Mile	0.55
End Levee Mile	0.65
Location	Land Side
Category	Earthen Levee
Item	Encroachments

Fall 2009 photo of livestock pens and house on landside slope.

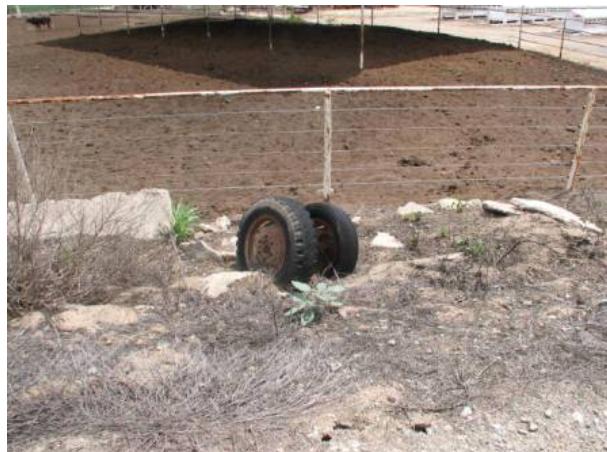
Levee Mile Report Line	16
Start Levee Mile	0.65
End Levee Mile	0.65
Location	Land Side
Category	Earthen Levee
Item	Encroachments

DWR ID: DWR_RD2031_01_s_2012_970
16	0.65	0.65	Earthen Levee	Encroachments	LS	M En	DE : Debris Inspector Comments: Tractor wheels on slope of landside levee.	37.702643 ° -121.160867 °	37.702643 ° -121.160867 °	35 Y
										DWR ID: DWR_RD2031_01_s_2012_35
17	0.67	0.70	Earthen Levee	Encroachments	LS	M En	FE : Fences	37.702457 ° -121.161052 °	37.702250 ° -121.161418 °	36 Y
										DWR ID: DWR_RD2031_01_s_2012_36
18	0.75	0.78	Earthen Levee	Encroachments	LS	M En	AD : Agricultural Ditch	37.701566 ° -121.161852 °	37.701178 ° -121.162086 °	972 Y
										DWR ID: DWR_RD2031_01_s_2012_972

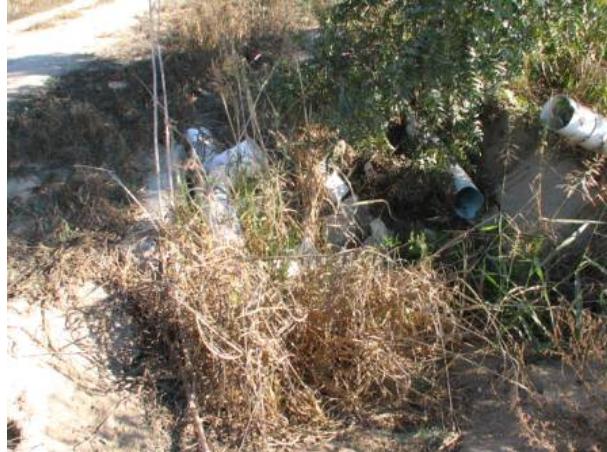
Levee Mile Report Line	19
Start Levee Mile	0.81
End Levee Mile	0.81
Location	Land Side
Category	Earthen Levee
Item	Encroachments
10/26/2011 Updated photo of PVC pipe pieces obstructing drain pipe, issue remains from Spring 2011 inspection.	
mkhashch_s_20120501_038.jpg

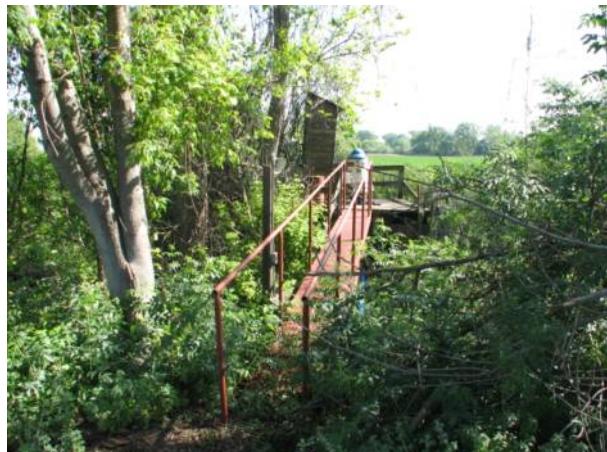
Levee Mile Report Line	21
Start Levee Mile	1.27
End Levee Mile	1.27
Location	Water Side
Category	Earthen Levee
Item	Encroachments
Irrigation intake pump and pipe.	
mkhashch_s_20120501_035.jpg

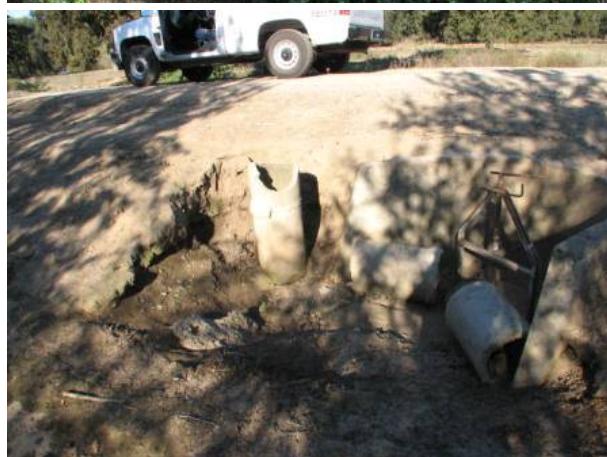
DWR ID: DWR_RD2031_01_s_2012_11	
22	1.58	1.58	Earthen Levee	Erosion / Bank Caving	LS Ma	M	E1 : Note and monitor erosion site. Inspector Comments: Erosion is active around the irrigation standpipe.	37.698776 ° -121.174327 °	37.698776 ° -121.174327 °	Y	3	
											DWR ID: DWR_RD2031_01_s_2012_3	
23	1.60	1.60	Earthen Levee	Erosion / Bank Caving	WS Ma	M	E1 : Note and monitor erosion site. Inspector Comments: Active erosion is occurring around irrigation inlet.	37.698610 ° -121.174598 °	37.698610 ° -121.174598 °	Y	8	
											DWR ID: DWR_RD2031_01_s_2012_8	
24	1.65	1.65	Earthen Levee	Erosion / Bank Caving	LS Ma	M	E1 : Note and monitor erosion site. Inspector Comments: Active erosion around irrigation inlet in levee prism.	37.698208 ° -121.175400 °	37.698208 ° -121.175400 °	Y	9	
											DWR ID: DWR_RD2031_01_s_2012_9	
25	1.88	1.88	Earthen Levee	Encroachments	WS En	M	DE : Debris Inspector Comments: Several bails of hay at toe of levee.	37.695867 ° -121.177638 °	37.695867 ° -121.177638 °	Y	37

Levee Mile Report Line	22
Start Levee Mile	1.58
End Levee Mile	1.58
Location	Land Side
Category	Earthen Levee
Item	Erosion / Bank Caving
10/26/2011 Active erosion into the levee prism around irrigation standpipe.	
mkhashch_s_20120501_030.jpg

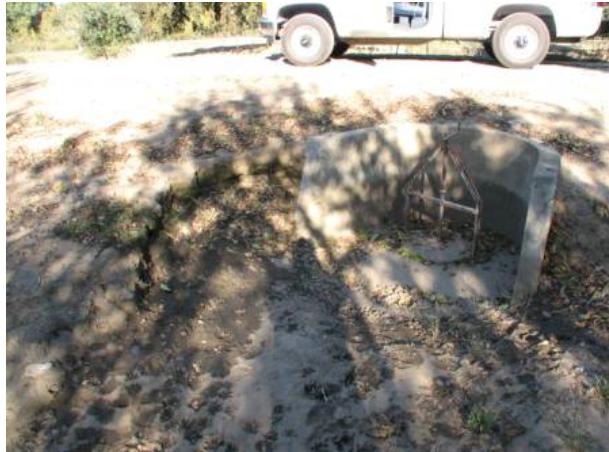
Levee Mile Report Line	23
Start Levee Mile	1.60
End Levee Mile	1.60
Location	Water Side
Category	Earthen Levee
Item	Erosion / Bank Caving
10/26/2011 Active erosion shown around irrigation inlet.	
mkhashch_s_20120501_032.jpg

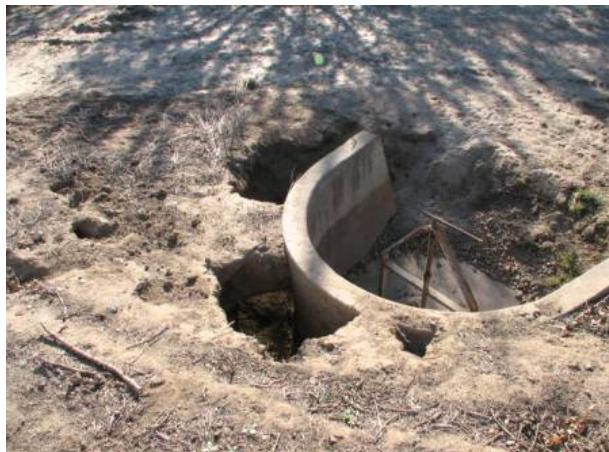
Levee Mile Report Line	24
Start Levee Mile	1.65
End Levee Mile	1.65
Location	Land Side
Category	Earthen Levee
Item	Erosion / Bank Caving
10/26/2011 Active erosion into levee prism around irrigation inlet.	
mkhashch_s_20120501_033.jpg

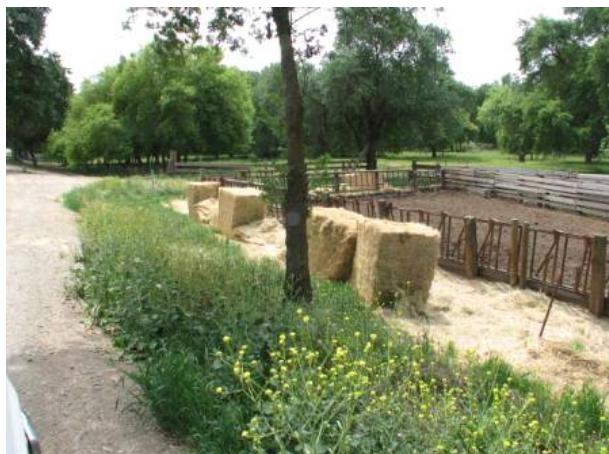
Levee Mile Report Line	25
Start Levee Mile	1.88
End Levee Mile	1.88
Location	Water Side
Category	Earthen Levee
Item	Encroachments
View of hay bails at toe of levee on waterward side, facing downstream. 05/02/2012	
mkhashch_s_20120510_079.jpg

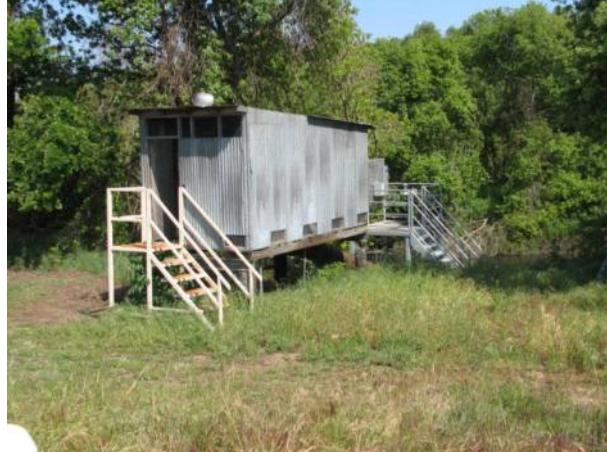
Levee Mile Report Line	35
Start Levee Mile	3.72
End Levee Mile	3.72
Location	Water Side
Category	Earthen Levee
Item	Encroachments
Irrigation intake on waterside berm.	
mkhashch_s_20120501_036.jpg

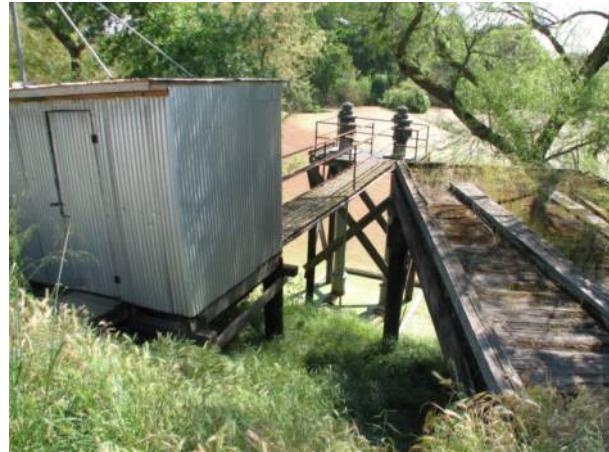
Levee Mile Report Line	1
Start Levee Mile	0.22
End Levee Mile	0.22
Location	Land Side
Category	Earthen Levee
Item	Encroachments
Drainage discharge pumps and housing on steep waterside slope.	
mhashch_s_20120501_045.jpg

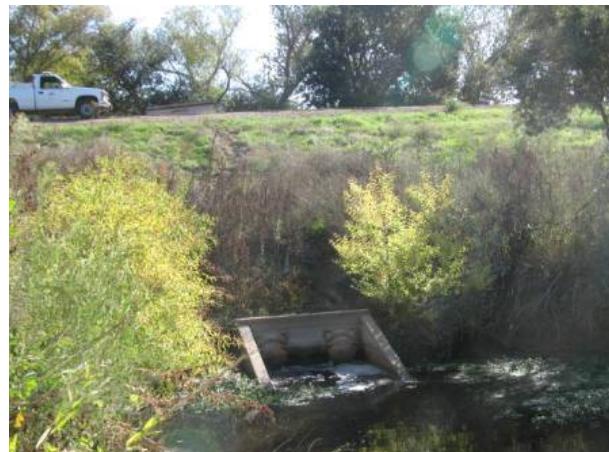
Levee Mile Report Line	1
Start Levee Mile	0.22
End Levee Mile	0.22
Location	Land Side
Category	Earthen Levee
Item	Encroachments
10/26/2011 Flap gates on landside.	
mhashch_s_20120501_046.jpg

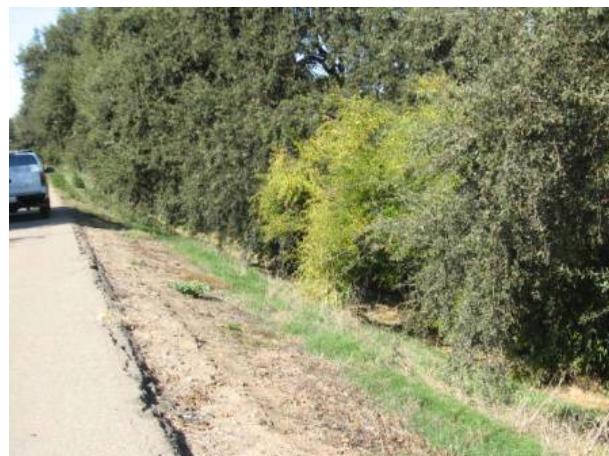
Levee Mile Report Line	2
Start Levee Mile	0.63
End Levee Mile	0.63
Location	Land Side
Category	Earthen Levee
Item	Trim / Thin Trees
10/26/2011 Trees on landside need to be trimmed up 5' above the ground to allow for visibility of the landside slope and toe.	
mhashch_s_20120501_049.jpg

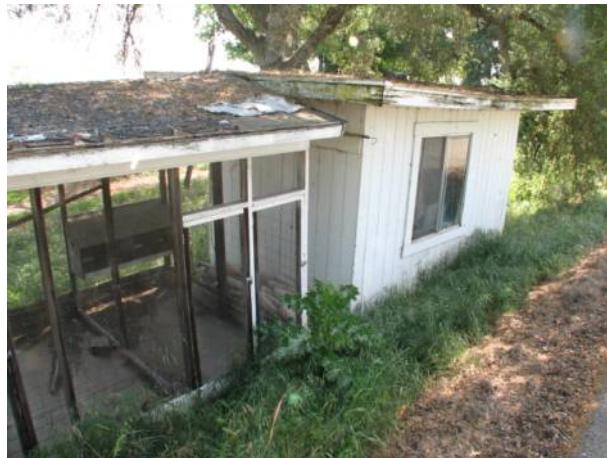
Levee Mile Report Line	3
Start Levee Mile	1.36
End Levee Mile	1.36
Location	Land Side
Category	Earthen Levee
Item	Encroachments
Small structure on levee slope.	
mkhashch_s_20120501_047.jpg

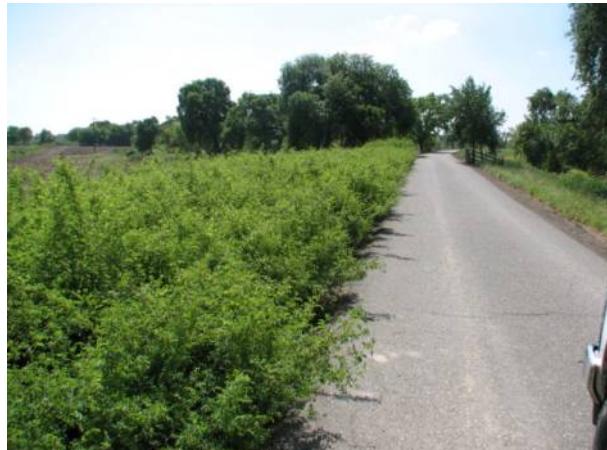
Levee Mile Report Line	4
Start Levee Mile	1.45
End Levee Mile	1.45
Location	Land Side
Category	Earthen Levee
Item	Vegetation
Wild rose on levee slope.	
mkhashch_s_20120501_060.jpg

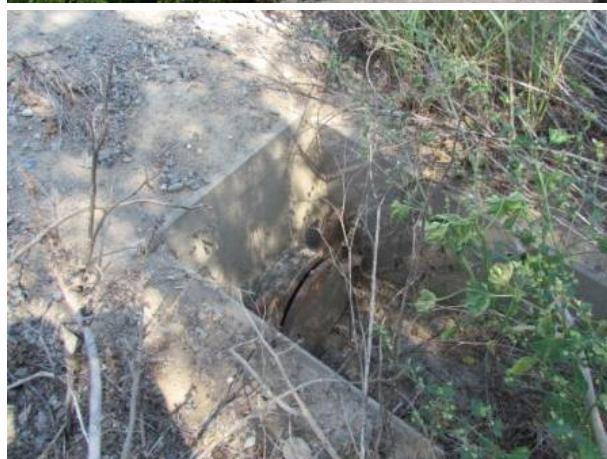
Levee Mile Report Line	6
Start Levee Mile	3.88
End Levee Mile	3.88
Location	Water Side
Category	Earthen Levee
Item	Encroachments
View of pipe with flap gate penetrating levee at waterside toe. 05/24/2012	
mkhashch_s_20120525_409.jpg

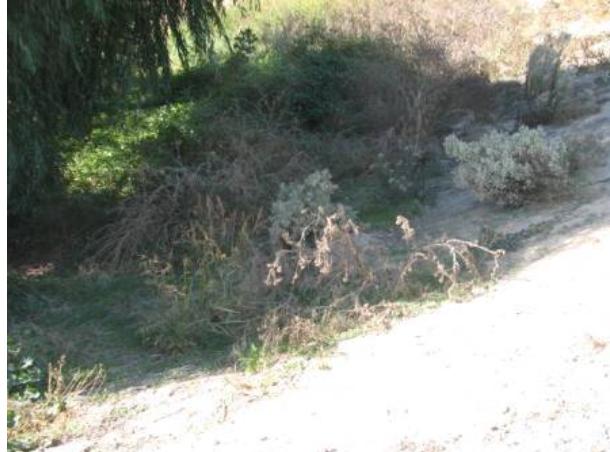
Levee Mile Report Line	7
Start Levee Mile	3.89
End Levee Mile	3.89
Location	Land Side
Category	Earthen Levee
Item	Vegetation
10/26/2011 Vegetation on landside obstructs visibility of the landside slope and toe.	
mkhashch_s_20120501_061.jpg

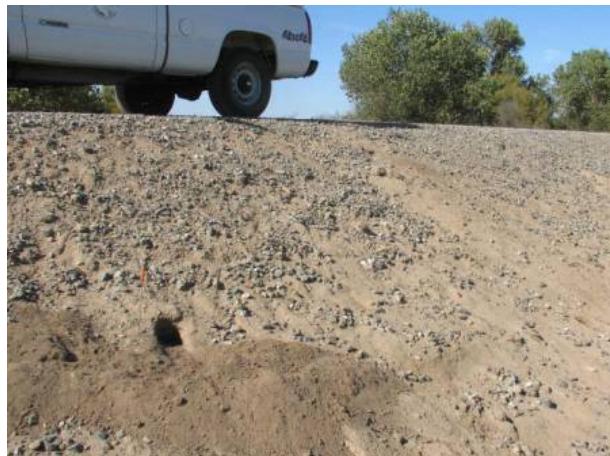
Levee Mile Report Line	8
Start Levee Mile	4.23
End Levee Mile	4.23
Location	Land Side
Category	Earthen Levee
Item	Animal Control
10/26/2011 Typical, burrow in area, several burrows at this location, many of them were flagged prior to the Spring 2011 inspection.	
mkhashch_s_20120501_048.jpg

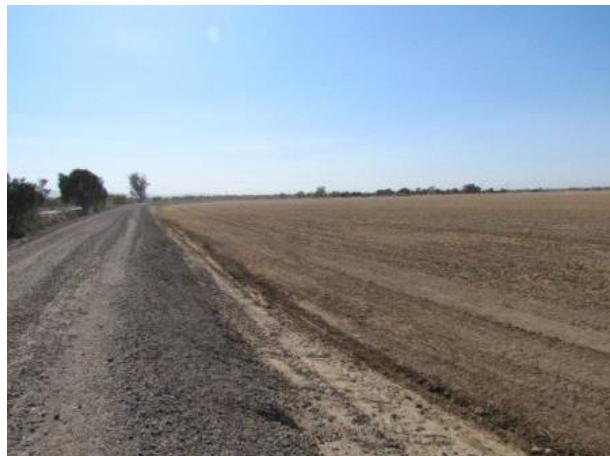
Levee Mile Report Line	9
Start Levee Mile	4.23
End Levee Mile	4.74
Location	Land Side
Category	Earthen Levee
Item	Encroachments
View of agricultural tilling up to landside toe looking west from LM 4.47. 05/24/2012	
mkhashch_s_20120525_413.jpg

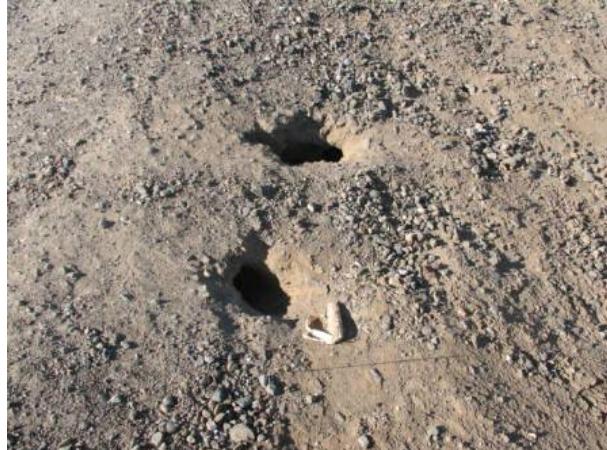
Levee Mile Report Line	10
Start Levee Mile	4.28
End Levee Mile	4.28
Location	Land Side
Category	Earthen Levee
Item	Animal Control
10/26/2011 Burrows that appear to be active, cleaned corn cob at entrance of one burrow.	
mkhashch_s_20120501_050.jpg

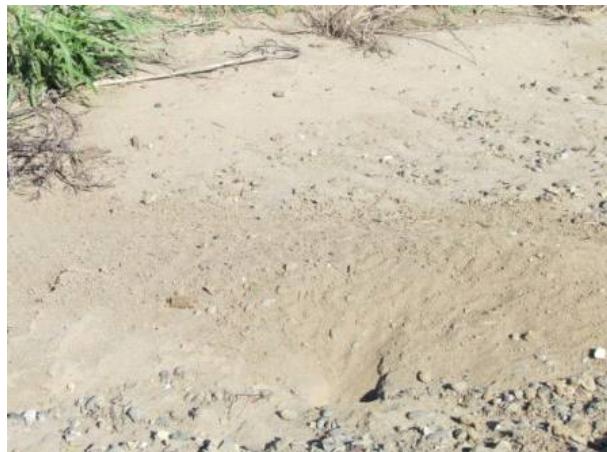
Levee Mile Report Line	10
Start Levee Mile	4.28
End Levee Mile	4.28
Location	Land Side
Category	Earthen Levee
Item	Animal Control
View of active borrow hole at landside toe. 05/24/2012	
mkhashch_s_20120525_410.jpg

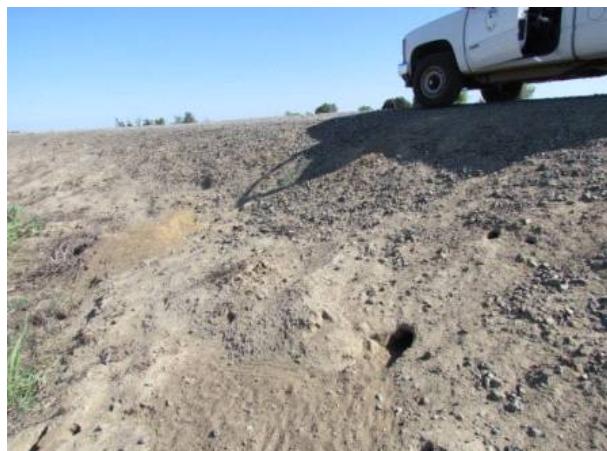
Levee Mile Report Line	10
Start Levee Mile	4.28
End Levee Mile	4.28
Location	Land Side
Category	Earthen Levee
Item	Animal Control
View of several active burrow holes at landside toe. 05/24/2012	
mkhashch_s_20120525_411.jpg

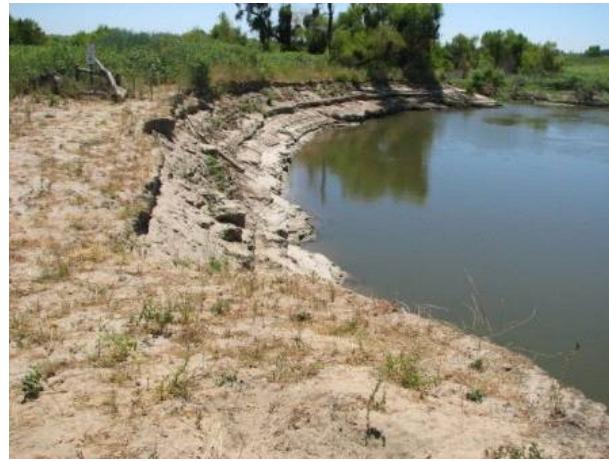
Levee Mile Report Line	11
Start Levee Mile	4.33
End Levee Mile	4.37
Location	Water Side
Category	Supplemental
Item	DWR Erosion Survey

Waterway								Bank	Unit Miles	Inspection Start/End	Inspector
L/MR No.	Levee Mile		Category	Item	* Location	* Rating	Action/Comment	GPS Latitude/Longitude		Issue No.	
	Start	End						Start	End		
11	4.33	4.37	Supplemental DWR Erosion Survey	WSA/W	Ma	Inspector Comments: 08/18/2011: No significant changes observed on the site. Dead trees and animal activities visible. The closest point of the erosion site to the levee toe is about 100 ft. 10/19/2010: There is active scouring occurring on the bank due to the nature of the flow and the lack of armor protection. There is also a fallen log immediately downstream of where the erosion has occurred and is protruding outward, possibly creating an eddy and scouring the bank. With the remaining 100-foot wide berm, the levee prism is not yet affected. However, the bank will continue to degrade, and eventually intrude into the levee prism if no protection is put in place. Erosion site is recommended for annual assessment and monitoring during flood events. [2011 Site ID:RD2031U02RM78.7]	37.631716 °	37.631716 °	1

Upstream view of adjacent bank affected by erosion. The loose sand visible on the site.

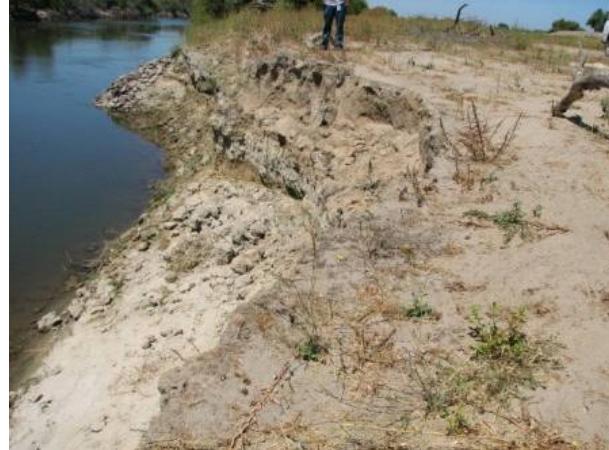
Levee Mile Report Line	11
Start Levee Mile	4.33
End Levee Mile	4.37
Location	Water Side
Category	Supplemental
Item	DWR Erosion Survey
A close look of the erosion. The loose sandy material visible.	
mkhashch_s_20120501_044.jpg

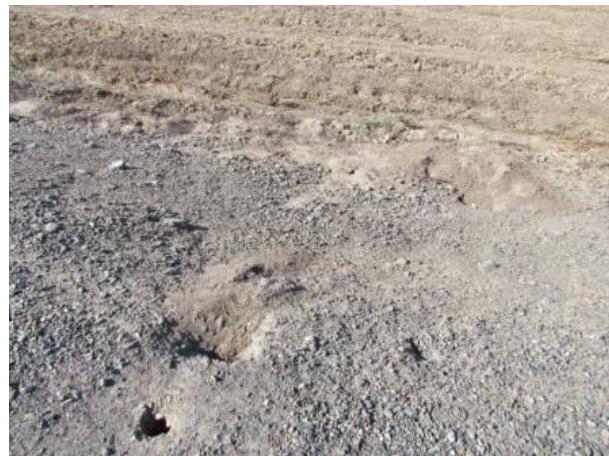
Levee Mile Report Line	12
Start Levee Mile	4.39
End Levee Mile	4.39
Location	Land Side
Category	Earthen Levee
Item	Animal Control
View of several active burrow holes at landside hinge and toe. 05/24/2012	
mkhashch_s_20120525_412.jpg

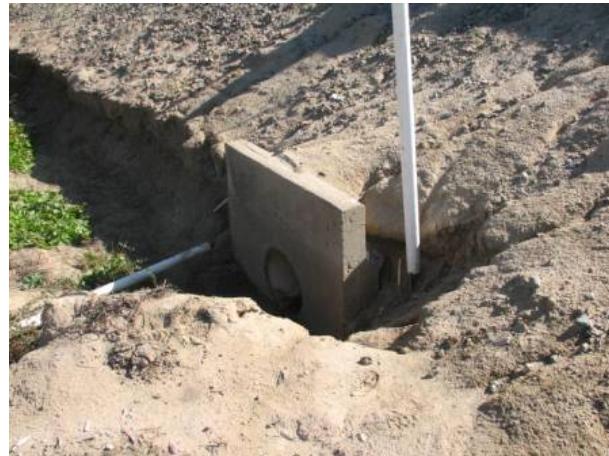
Levee Mile Report Line	13
Start Levee Mile	4.75
End Levee Mile	4.75
Location	Land Side
Category	Earthen Levee
Item	Encroachments
10/26/2011 Photo shows landside of 14" PVC pipe through levee. No flap gate or closure device observed.	
mkhashch_s_20120501_051.jpg

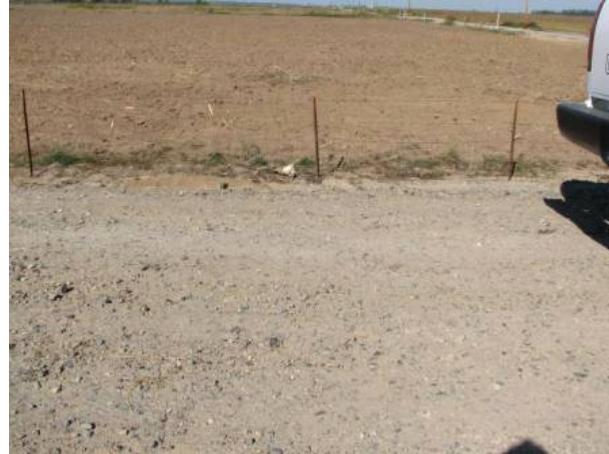
Levee Mile Report Line	15
Start Levee Mile	5.33
End Levee Mile	5.33
Location	Land Side
Category	Earthen Levee
Item	Animal Control
10/26/2011 Photo taken from location of waterside burrow to show relationship to landside burrow, which can be noted by fresh material seen over the levee crown approximately 2' to the left in this photo.	
mkhashch_s_20120501_054.jpg

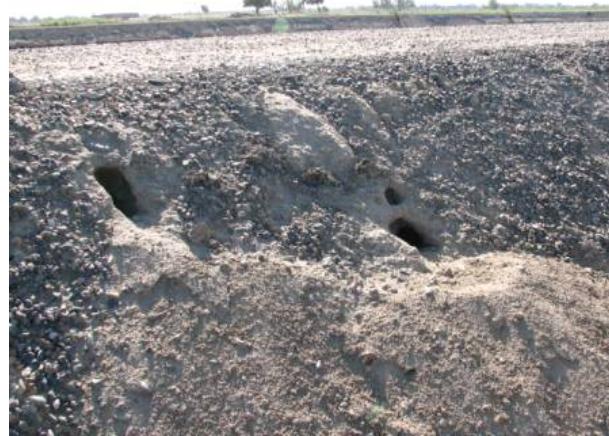
Levee Mile Report Line	16
Start Levee Mile	5.46
End Levee Mile	5.46
Location	Land Side
Category	Earthen Levee
Item	Animal Control
10/26/2011 Multiple burrows shown on the landside.	
mkhashch_s_20120501_055.jpg

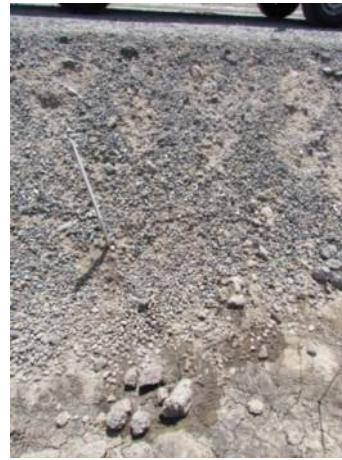
Levee Mile Report Line	17
Start Levee Mile	5.51
End Levee Mile	5.51
Location	Land Side
Category	Earthen Levee
Item	Seepage / Sandboils
View of seepage at toe; clear water present at the saturated spot. 05/15/2012	
mkhashch_s_20120529_416.jpg

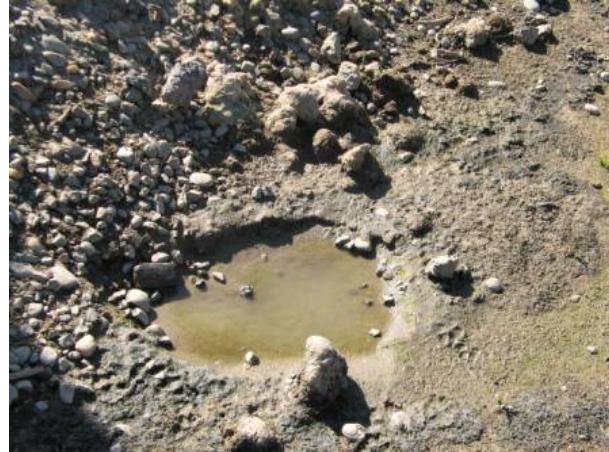
DWR ID: DWR_RD2031_02_s_2012_8											
18	5.54	5.54	Earthen Levee	Seepage / Sandboils	LS	U	Inspector Comments: 10/26/2011 Possible sand boil observed. Note that there is damage to the concrete channel directly across on the waterside of the levee from this issue. FIR filed for this issue, FIR no. 4422.	37.630797 °	37.630797 °	15	
					Ob			-121.168204 °	-121.168204 °	Y	
DWR ID: DWR_RD2031_02_s_2012_15

Levee Mile Report Line	18
Start Levee Mile	5.54
End Levee Mile	5.54
Location	Land Side
Category	Earthen Levee
Item	Seepage / Sandboils
10/26/2011 First of three photos showing possible sand boil, appears to be a deposition of material as evidenced by the shadows on the upper side of the boil.	
mkhashch_s_20120501_056.jpg

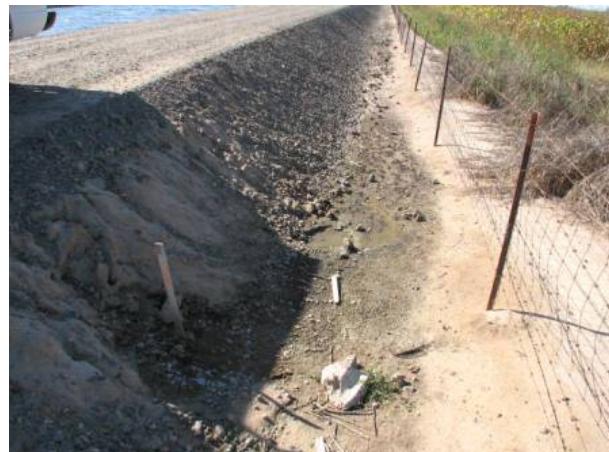
Levee Mile Report Line	18
Start Levee Mile	5.54
End Levee Mile	5.54
Location	Land Side
Category	Earthen Levee
Item	Seepage / Sandboils
10/26/2011 Photo shows location of boil relative to the levee.	
mkhashch_s_20120501_057.jpg

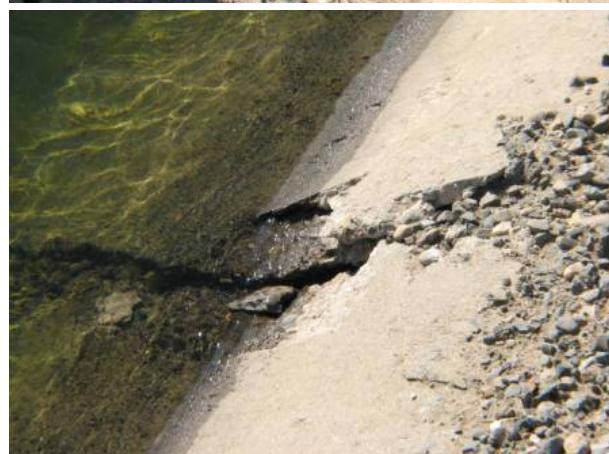
Levee Mile Report Line	18
Start Levee Mile	5.54
End Levee Mile	5.54
Location	Land Side
Category	Earthen Levee
Item	Seepage / Sandboils
10/26/2011 This concrete damage is located directly across the levee crown from the boil location.	
mkhashch_s_20120501_058.jpg

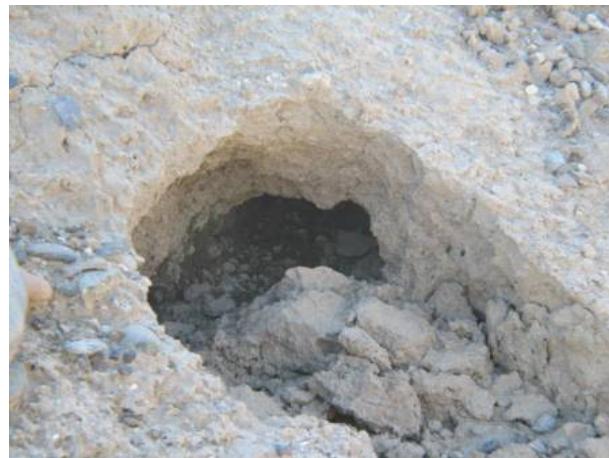
Waterway							Bank	Unit Miles	Inspection Start/End	Inspector		
LMR No.	Levee Mile		Category	Item	* Location	* Rating	Action/Comment			GPS Latitude/Longitude	Issue No.	
	Start	End					Start	End	Photo			
19	5.65	5.65	Earthen Levee	Erosion / Bank Caving	LS U Ma	Inspector Comments: Active erosions occurring. Appears to be a hole behind the levee penetrating into the prism. Cracks observed above the hole on the levee slope. The waterside of the levee is a concrete lined MID irrigation canal.	37.630794 °	37.630794 °	16	-121.166179 °	-121.166179 ° Y	
20	5.98	5.98	Earthen Levee	Encroachments	WSA/W PI : Pipe	En	Inspector Comments: Gas Pipeline	37.630630 °	37.630630 °	2	-121.159720 °	-121.159720 ° Y

Levee Mile Report Line	19
Start Levee Mile	5.65
End Levee Mile	5.65
Location	Land Side
Category	Earthen Levee
Item	Erosion / Bank Caving
10/23/2011 Erosion located on the landside of the levee. Cracking above the hole in the levee slope and hole extends into the levee prism.	
mkhashch_s_20120501_059.jpg

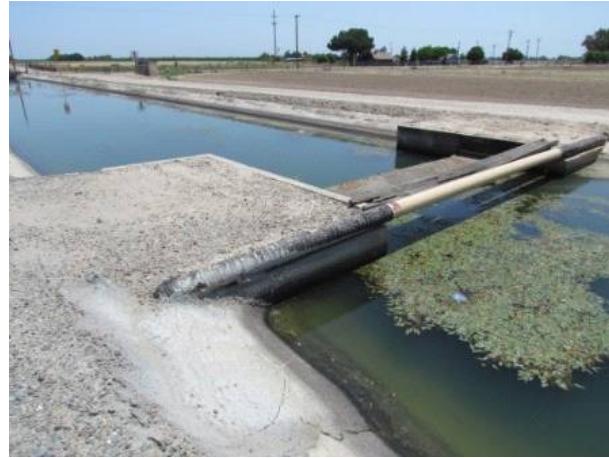
Levee Mile Report Line	20
Start Levee Mile	5.98
End Levee Mile	5.98
Location	Water Side
Category	Earthen Levee
Item	Encroachments
View of gas pipeline penetrating levee. 05/15/2012	
mkhashch_s_20120529_414.jpg
